Center for Irrigation Technology

This is a report on the laboratory measurements made on the NMG (No More Geysers) units. Reference is also made to the attached file that shows hydrozone layout on which the hydraulic measurements were made.

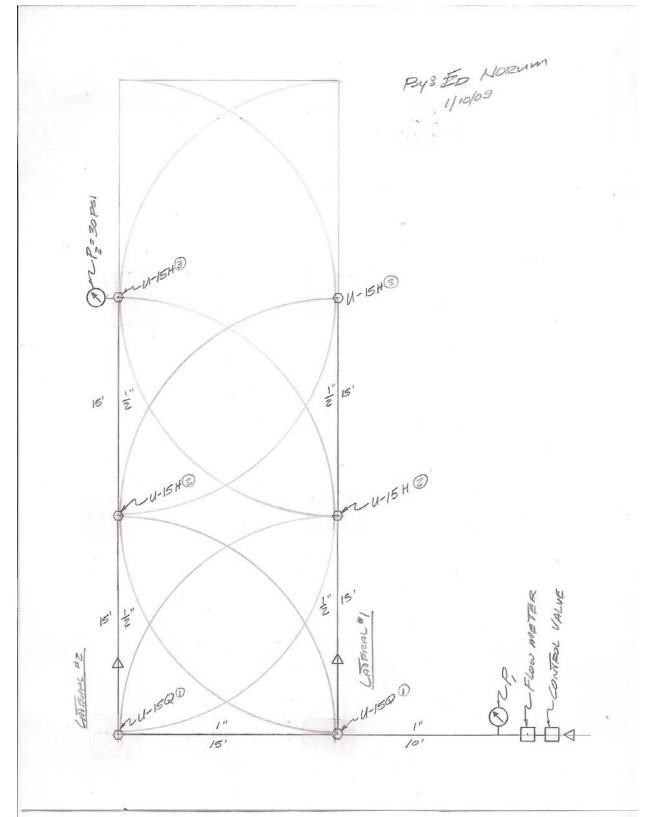
- Step #1 Setup the hydrozone configured as shown on the attached sketch. Adjust the inlet pressure so as to provide 30 psi at location P2.
- Step #2 Measure the flow rate thru the system first w/o the NMG units, 8.8 gpm. Measure the flow rate w/ NMG units installed, 8.6 gpm. Using the catalog values for the individual sprayers a value of 9.24 gpm is suggested. The presence of the NMG units in the system causes a small, 2.3% reduction in flow rate. These were full length NMG units.
